INCREASED RELIABILITY FOR PV IN ALPINE ENVIRONMENT

Anika Gassner^{1,5}, Gabriele C. Eder¹, Ebrar Özkalay², Gabi Friesen², Markus Feichtner³, Markus Babin^{1,4}, Friedrich Bleicher⁵

No specific accelerated aging tests are currently available to simulate these harsh alpine conditions. Therefore, the main objective of the PV-Detect project is to develop an advanced test methodology for an accelerated and optimized product development of PV modules suitable for operation in demanding environments (e.g. strong solar radiation, heavy snow or wind loads).

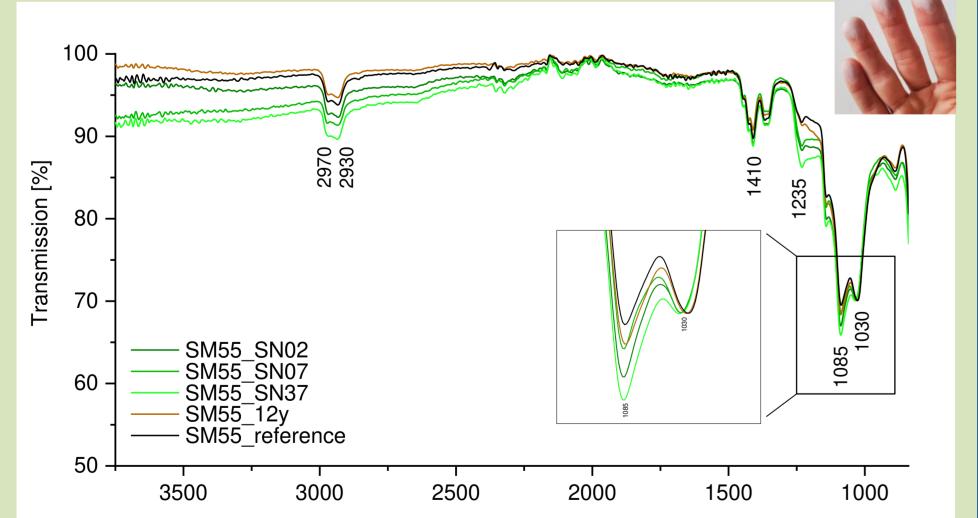
Kanzelhöhe

Montane zone - 1530 m Modules SM55/installed in 1988/1992

Visual inspection & UV-Fluorescence:

- Yellowing of encapsulant only in modules from 1988
- EVA was modified for modules in 1992
- Strong fluorescence in the old modules

NIR and IR identified it as EVA and Tedlar (PVF/PET/PVF) IR: surface degradation of outer backsheet layer (PVF) -> chalking and chemical changes

1992 1988 1988

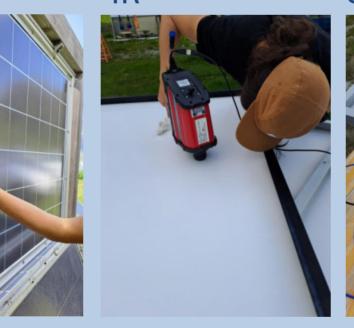
Lac de Toules

Sub-alpine zone - 1800 m PERT Modules installed in 2013 Reference system in lowlands: BAPV

NIR and IR identified it as EVA and Tedlar (PVF/PET/PVF) IR

UV/Vis-color microscopy

In the alpine environment, the polymeric materials did not show aging effects so far. Only one backsheet had a mechanical failure (figure on the right). Only BAPV modules showed cell discoloration.

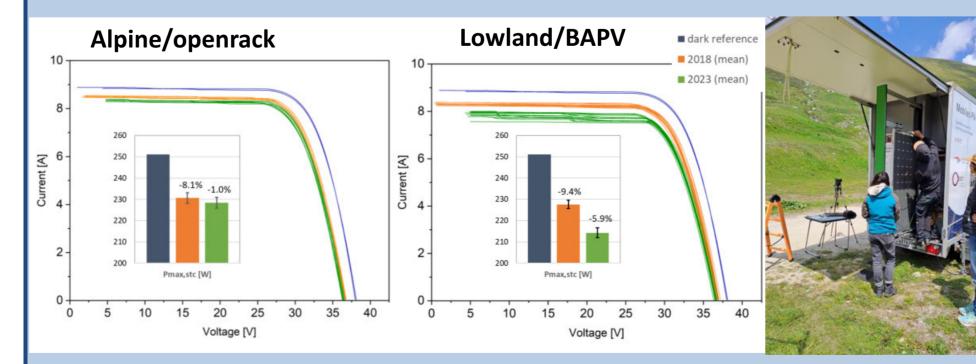
Electrical measurements [3]:

Degradation in alpine environment less then in lowland/BAPV.

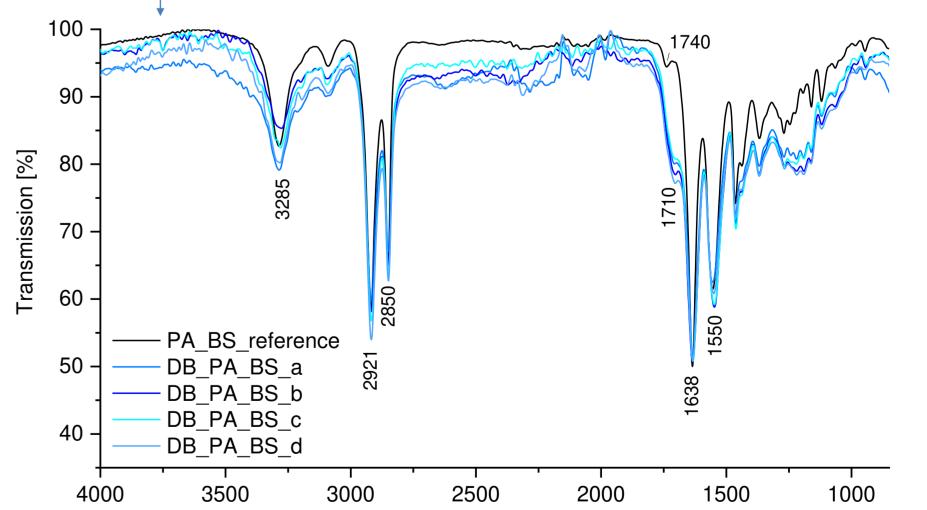
Dobratsch

Alpine zone - 2050 m Two module types (c-Si) installed 201

Visual inspection & light microscope: **Backsheet I: intact**

- \rightarrow NIR identified the BS as Polypropylene-stack PP
- \rightarrow PP/PP/PP

Backsheet II: cracked

- Longitudinal cracks along busbars
- Microcracks
- \rightarrow NIR identified the BS as pure Polyamide
- \rightarrow PA/PA/PA

IR: Photo-oxidative degradation of outer BS surface in PA & PP
